Bird's Nest Inferior Vena Caval Filter Migration into the Duodenum: A Rare Cause of Upper Gastrointestinal Bleeding

Hasan Ali Al Zahrani, FRCS (Glasgow)

Purpose: To report the first case of a potentially catastrophic complication of vena caval interruption with a bird's nest filter.

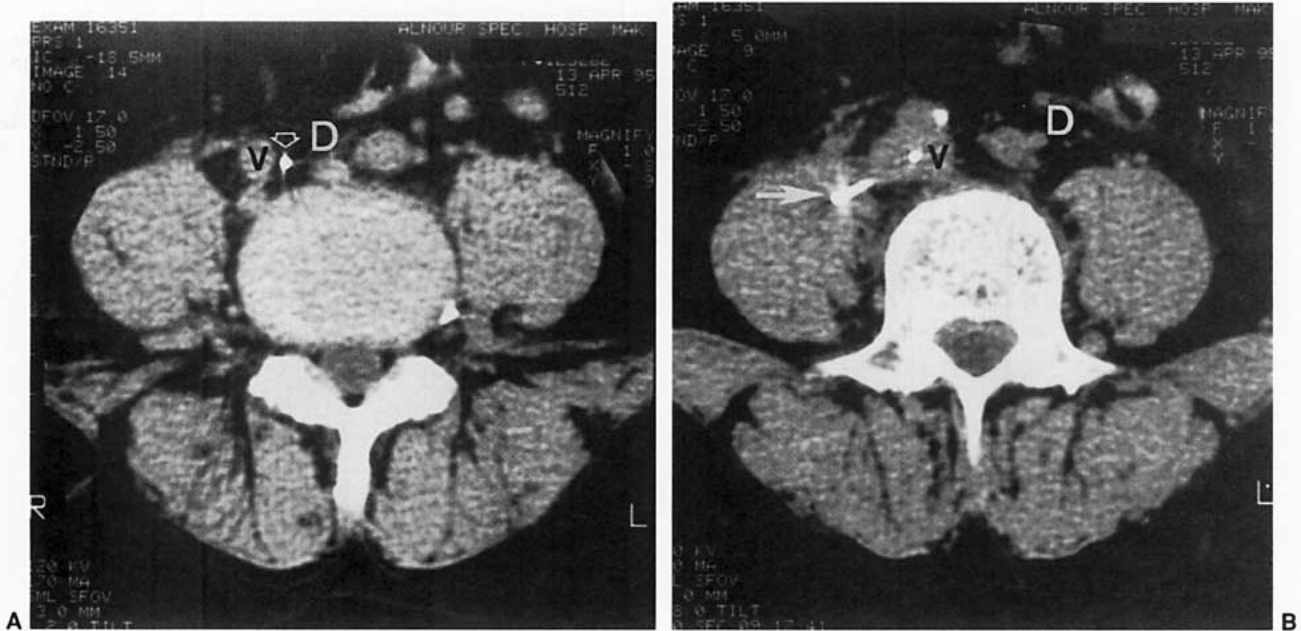
gent computed tomography (CT) visualized one filter wire projecting from the IVC and penetrating the duodenum. Furthermore, a hook was seen penetrating the right psoas muscle.

Figure 1 ♦ (A) Follow-up CT scan of the abdomen 1 year after surgery to repair duodenal perforation caused by migration of a bird's nest filter. The remnant of the wire (arrow), which had penetrated the inferior vena cava (V), can be seen. (B) The same scan showing the filter hook (arrow) embedded in the psoas muscle. D = duodenum.

An emergency laparotomy was performed on the night of admission. The abdomen was opened via a midline incision. Many adhesions were encountered among the duodenum, gallbladder, and transverse colon; these were lysed, and the duodenum was mobilized with a Kocher maneuver. The duodenum was then incised and examined. Three round, 2- to 3-cm-diameter, actively bleeding ulcers were seen near the ampulla of Vater. One of these communicated with the IVC, which had been penetrated by a hook. The wire protruding into the duodenum was transected with a wire cutter, the ulcers were oversewn in standard fashion, and the duodenotomy was closed in two layers. The vena cava was not opened, but the hook projecting from the IVC was cut flush with the vena caval wall using the wire cutter. A large omental pedicle was transposed between IVC and the displaced duodenum. Morrison's pouch was drained, and the abdomen was closed in layers in standard fashion. The patient received transfusions of fresh blood and packed cells to correct his anemia.

wall perforation by a hook during device delivery due to excessive traction on the wire guide pusher. More recently, Perry and Wells¹² reported structural failure of the hooks in a bird's nest filter. In none of these cases, however, was there any clinical sequela. Unfortunately, CT scans were not obtained in these patients to exclude injury to adjacent structures. In our case, however, the CT image confirmed that the filter's hook and wire had penetrated not only the duodenum but also the psoas muscle.

Wire breakage in this situation may have resulted from improper device selection because the patient had only a 17-mm-diameter IVC, a relative contraindication to bird's nest

filter insertion.^{7,10} Further, during the initial device placement in 1989, multiple attempts were required to correctly position the filter, which had just been released to market. This may indicate limited operator experience for a device that was subsequently found to be more operator dependent to deploy than other types of IVC filters.^{3,8} To correct this problem, the bird's nest filter has recently been modified with an improved deployment system.
